This document addresses transceiver-related known errata for the Stratix® GX FPGA family production devices.

Receiver Phase Compensation FIFO

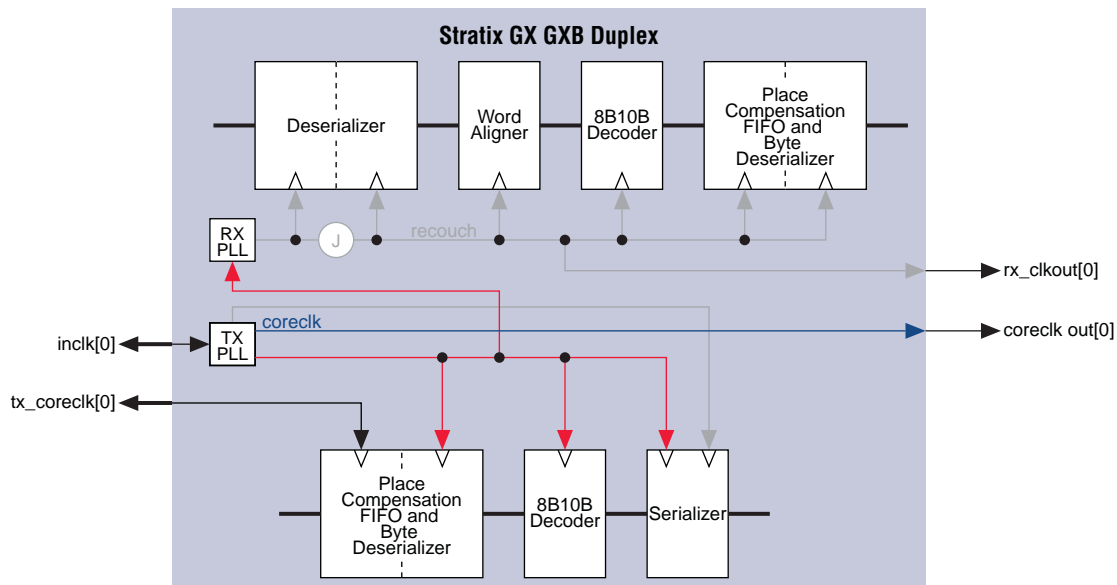
Figure 1. Gigabit Transceiver Block Clock Configuration that Does Not Cause Byte Misalignment Problem

This problem only occurs if the read clock of the phase compensation FIFO of a channel is fed from a clock source other than its own recovered clock. For example, [Figure 1](#) shows a clock configuration that avoids this problem.

From [Figure 1](#), the recovered clock (`rx_clkout[0]`) is fed to both the read and write clocks of the phase compensation FIFO. This is the default configuration of ALTGX megafunction. The Quartus[®] II software automatically routes the clocks into both sides of the FIFO to ensure that proper timing is met.

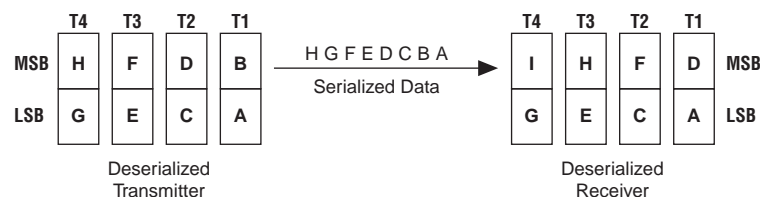
Figure 4. Byte Misalignment at the Receiver Interface

However, if a free running synchronous clock is connected to the rx_coreclk port and the gigabit transceiver block receiver is configured to be in double width mode, the byte ordering can have six possible combinations. The reordering happens when the receiver is coming out of the rxdigitalreset. Any byte misalignment that happens at this time will not subsequently change unless the reset is asserted again.

If the transceiver is clocked by any of the methods other than the default method described above, there is a possibility of byte misalignment. Figure 4 provides an example of byte misalignment.

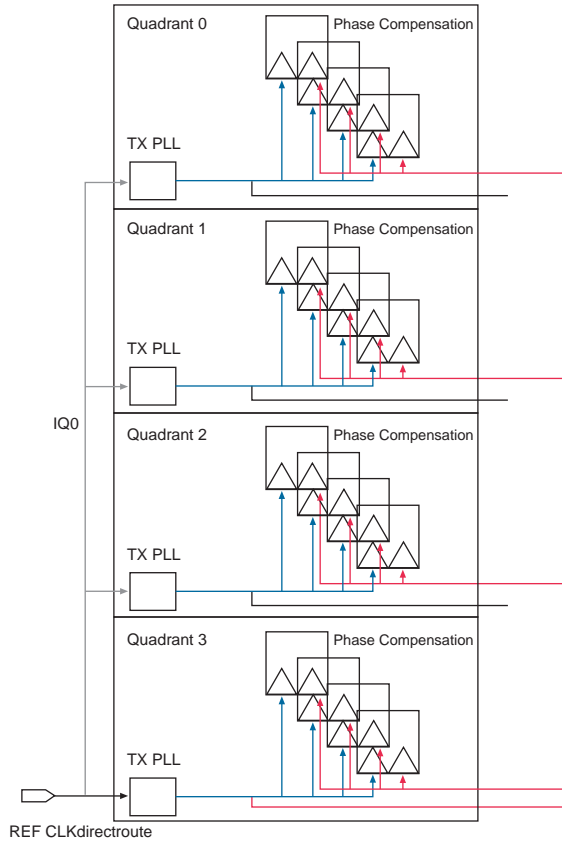
Figure 6. Transmit Phase Compensation FIFO Clocking Across Quadrants over IQ Lines

FIFOs that share a transmitter PLL `refclk` output from one transceiver block across transceiver blocks. [Figure 6](#) shows IQ routing used for the `refclk` output across quads. [Figure 7](#) shows global clock routing being utilized.
