Introduction

This errata sheet provides updated information on Stratix® II GX devices. This document addresses known device issues and includes methods to work around the issues.

Stratix II GX Device Family Issues

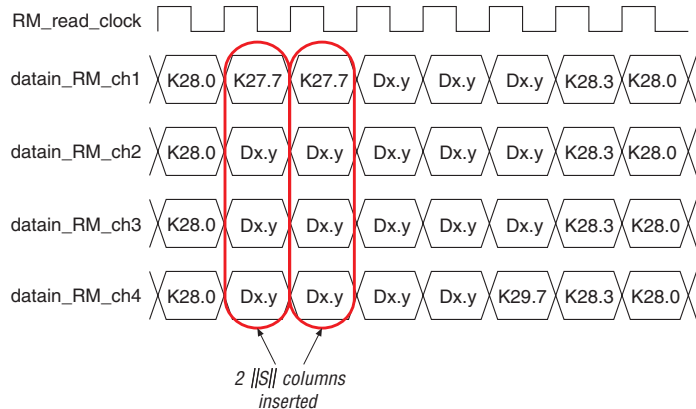
Figure 1. Rate Matcher Duplicating $\|S\|$ Column

In the XAU1 operating mode, the Stratix II GX rate matcher might insert a duplicate Start Column (||S||), causing corruption of the data packet.

When the rate matcher has to insert $\|R\|$ for clock rate compensation, there are instances where the rate matcher inserts a duplicate $\|S\|$. This duplication causes packet corruption. The duplication of $\|S\|$ happens only when the rate matcher block's insertion logic has to insert multiple $\|R\|$ columns before the $\|S\|$ column. This is shown in [Figure 1](#).

Altera has implemented a solution for this issue in the Quartus II software version 7.1.

If you have implemented a Stratix II GX XAUI design in versions prior to the Quartus II software version 7.1, recompile your design in the Quartus II software version 7.1.

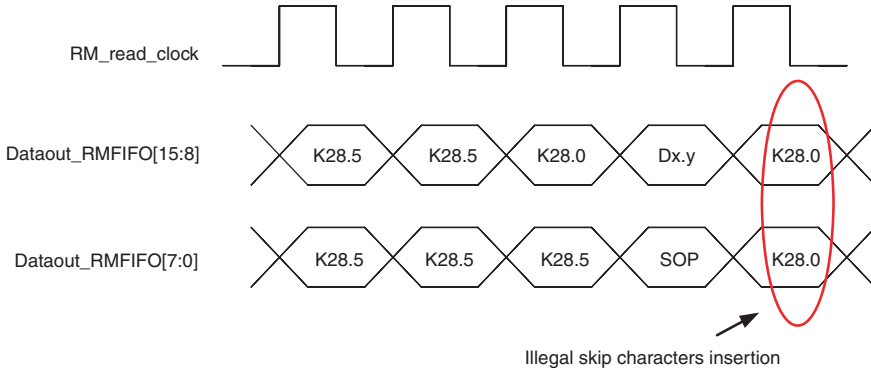
Figure 2. Illegal Insertion of /R/ Characters After the Start of Packet (SOP)

In Basic double-width mode, the Stratix II GX rate matcher may insert skip characters after the start of packet under certain conditions, as explained below. This causes corruption of the data packet.

- if the rate matcher has to insert skip characters for clock compensation **AND**
- the control and the skip characters are received in the lower and upper byte of the data stream, respectively, immediately before the start of packet (SOP)

Figure 2 shows an example of illegal insertion with /K28.0/ and /K28.5/ programmed as skip and control characters, respectively.

Quartus II software version 7.2 provides an **Enable insertion or deletion of consecutive skip characters or ordered sets** option in the ALT2GXB MegaWizard (**BASIC1** screen). By default, this option is unchecked to work-around the issue.

When this option is unchecked, the rate matcher does not insert or delete back-to-back skip characters.
