This errata sheet provides updated information on Stratix® devices. This document addresses known issues and includes methods to work around the issues.

Stratix Family Issues

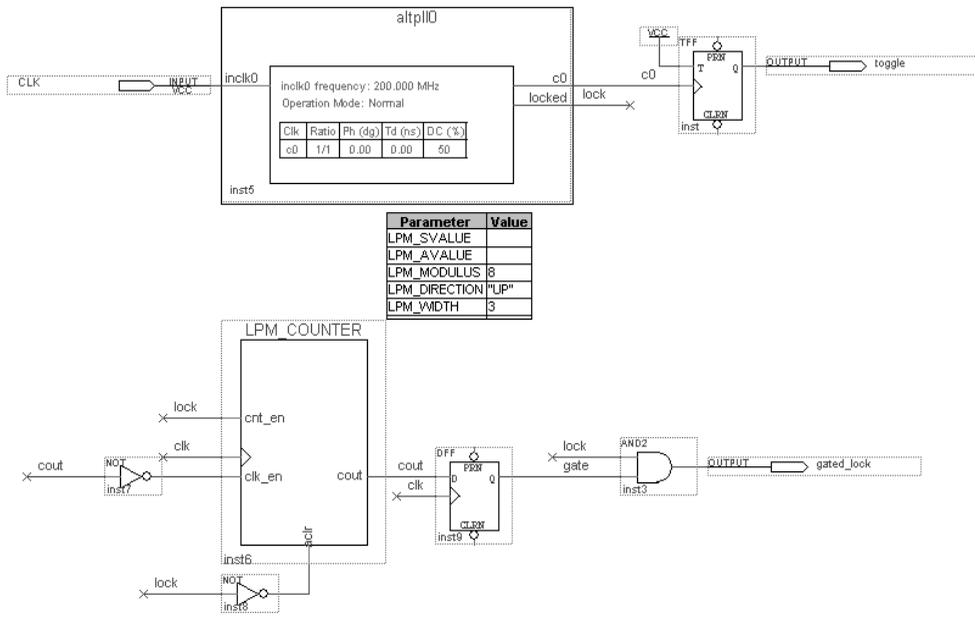
Figure 2. Gated Lock in Internal Logic Circuit

There is a run-through problem in the `GLOCK` counter that causes the counter to operate incorrectly. Support for the `gated_lock` circuitry was disabled in the Quartus II software version 2.1. Therefore, the `gated_lock` feature is unavailable in Stratix devices.

The work around for this problem is to gate the `lock` signal in internal logic. Altera recommends using a two-input `AND` gate to gate the `lock` signal with a counter. The number of bits in the counter (`LPM_WIDTH`) can be adjusted to control how many clock cycles before the `gated_lock` signal is released. The counter width in the reference design is currently 3. See [Figure 2](#).

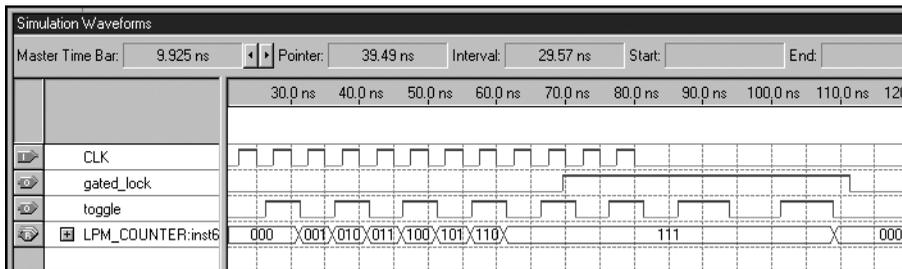
Figure 3. Gated Lock Signal Simulation Waveform

Figure 3 shows the simulation waveform of the gated lock signal. The gated_lock signal transitions high on the 10th clock cycle and is driven low after the PLL loses lock. The toggle signal frequency decreases as the V_{CO} frequency of the PLL begins to drift.

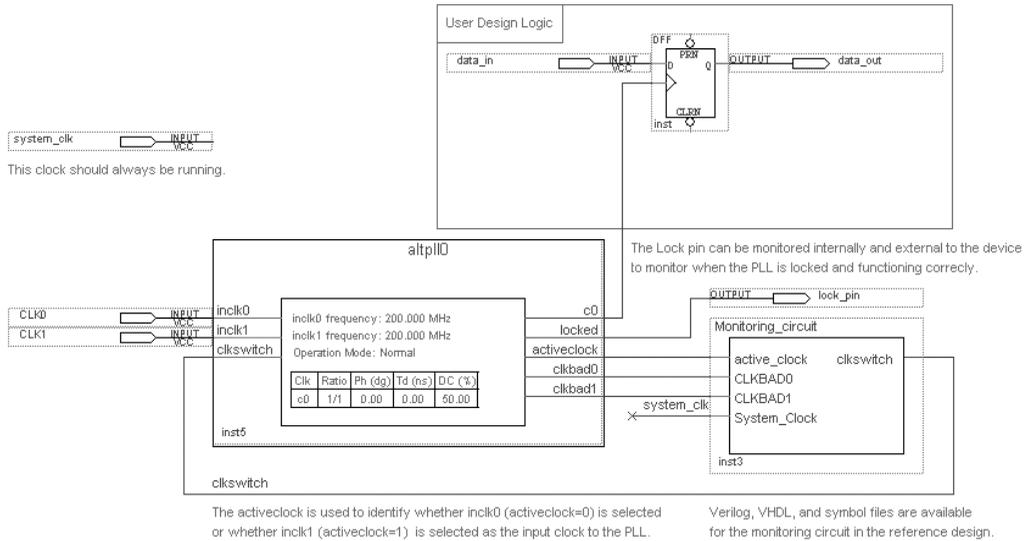
Figure 4. Clock Switchover Circuit

The CLKBAD0 and CLKBAD1 signals have a design flaw that cause a glitch on the signals. The glitches last for up to a half clock cycle of the input clock to the PLL. To prevent switchover from happening prematurely, a monitoring circuit is used to require the CLKBAD signal for the selected clock to be high for four consecutive system clock cycles before the PLL will switchover to the other clock.

To work around this issue, designers need to use the monitoring circuit as shown in [Figure 4](#) when designing for clock switchover. The monitoring circuit watches CLKBAD0, CLKBAD1, and the `activeclock` signals from the PLL. The monitoring circuit switches the PLL from `inclk0` to `inclk1` when CLKBAD0 is detected for four consecutive system clock cycles; the monitoring circuit switches the PLL back from `inclk1` to `inclk0` when CLKBAD1 is detected for four consecutive system clock cycles.

In the circuit shown in [Figure 4](#), CLK0 is the primary clock and CLK1 is the secondary clock. The `locked` signal can be used in the core and external to the device for monitoring the lock status of the PLL. The ALTPLL megafunction also has a `clkloss` output signal that can be monitored to determine when the clock switchover circuit initiates. `clkloss` goes high when the input clock is lost. If the primary clock fails and the secondary clock is not available, the clock switchover circuit continues to wait for a good secondary clock. The `activeclock` signal can be used in the core and external to the device for monitoring whether `inclk0` or `inclk1` is selected as the input clock to the PLL. A system clock that is guaranteed to be running at all times after the Stratix device is configured should be used to clock the monitoring circuit. Verilog HDL, VHDL, and schematic files are available in the reference design. It also contains waveform simulation and Verilog HDL and VHDL test bench files.

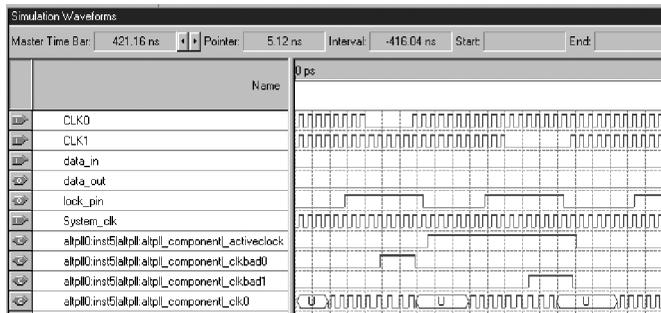
Figure 5. Simulation Results of Switchover Event

Figure 5 shows the simulation waveform of the PLL switchover events. When CLKBAD0 is high for four consecutive system clock cycles, the PLL switches to CLK1 as the primary clock. After CLKBAD1 is high for four consecutive system clock cycles, the PLL switches back to CLK0 as the primary clock.
