Introduction

This document addresses transceiver-related known errata for the Stratix® GX FPGA family production devices.

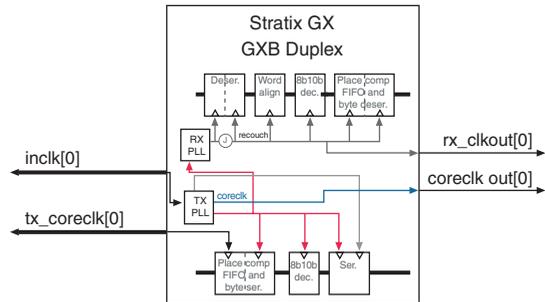
Figure 1. Gigabit Transceiver Block Clock Configuration that Does Not Cause Byte Misalignment Problem

This problem will only occur if the read clock of the phase compensation FIFO of a channel is fed from a clock source other than its own recovered clock. For example, [Figure 1](#) shows a clock configuration that avoids this problem:

From [Figure 1](#), the recovered clock (`rx_clkout[0]`) is fed to both the read and write clocks of the phase compensation FIFO. This is the default configuration of `ALTGXB` megafunction. The Quartus® II software automatically routes the clocks into both sides of the FIFO to ensure that proper timing is met.

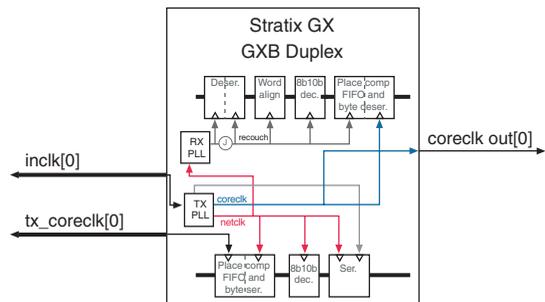
Figure 2. Gigabit Transceiver Block Clock Configuration that can Potentially Cause Byte Misalignment Problem, Example 1

However, if a free running synchronous clock is connected to the rx_coreclk port and the gigabit transceiver block receiver is configured to be in double width mode, the byte ordering can have six possible combinations. The reordering happens when the receiver is coming out of the rxdigitalreset. Any byte misalignment that happens at this time will not subsequently change unless the reset is asserted again.

[Figures 2](#) and [3](#) show clocking schemes with potential byte misalignment problems.

The recommended workaround is to run the gigabit transceiver block in the default clocking scheme, as described above, and implement a phase compensation FIFO in the FPGA logic array. This configuration of the gigabit transceiver block will prevent byte misalignment. This would utilize additional resources and increase latency in the datapath. A phase compensation FIFO can be implemented in the FPGA logic array using a Dual Port RAM, however you decide on the FIFO parameters to meet system specifications. Another thing to be aware of is the additional clock resources needed for this implementation. Each channel will require the use of a global, regional, or fast regional routing resource for the recovered clock (`rx_clkout`) to be routed out of the gigabit transceiver block. Figure 5 shows an example of this workaround.

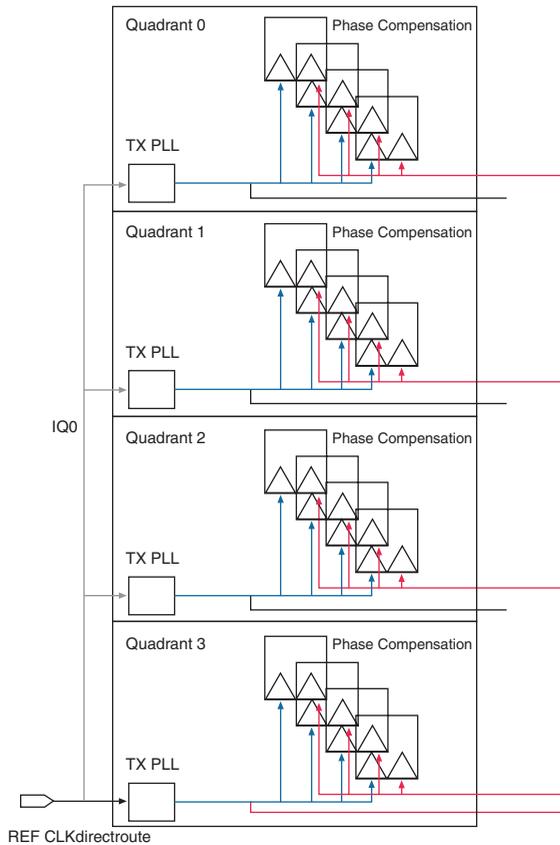
Figure 6. Transmit Phase Compensation FIFO Clocking Across Quadrants over IQ Lines

Figures 6 and 7 show the clocking schemes allowed for transmit phase compensation.

FIFOs that share a transmitter PLL `refclk` output from one transceiver block across transceiver blocks. **Figure 6** shows IQ routing used for the `refclk` output across quads. **Figure 7** shows global clock routing being utilized.
