# Intel® Stratix® 10 GX Device Errata

## Intel® Stratix® 10 GX Device Errata

This errata sheet provides information about known device issues affecting Intel® Stratix® 10 GX devices.

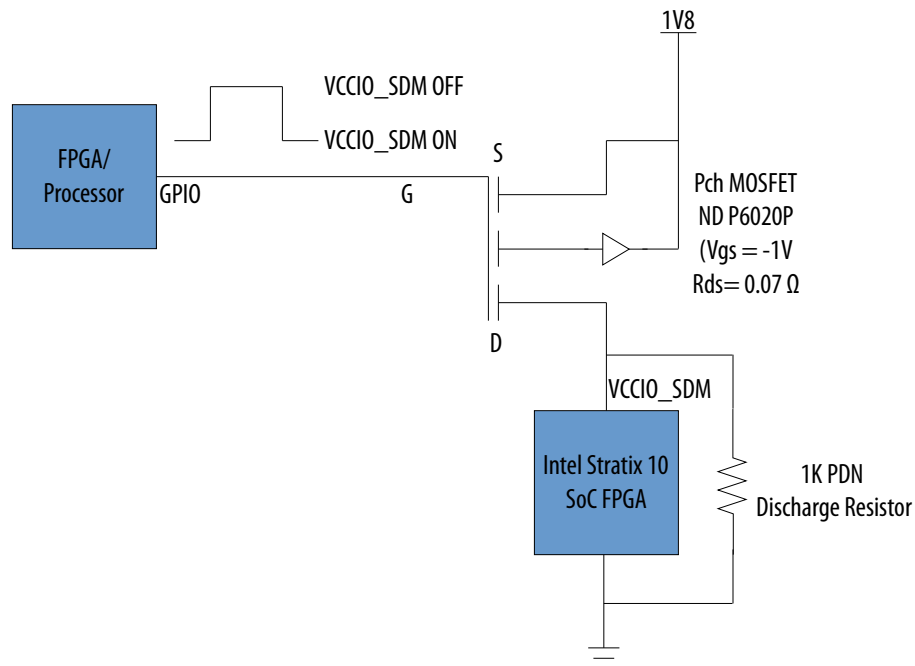
**Figure 1. Hardware Workaround**

Your device may encounter intermittent configuration failures if it is not programmed with at least 256 kB of configuration data within 18 seconds after completion of the power up sequence. This erratum does not apply to FPGA reconfiguration, provided a successful configuration was completed after the power up sequence. If the `nSTATUS` pin remains low for 110 ms after toggling the `nCONFIG` pin from low to high, it may indicate you have encountered this issue. To confirm, toggle `nCONFIG` again and if the `nSTATUS` pin remains low for another 10 ms, then you have confirmed the failure.

**Hardware workaround:** Use a MOSFET as a switch to briefly toggle the `VCCIO_SDM` voltage level when the host is ready to configure the FPGA using an arrangement as shown in the figure below.

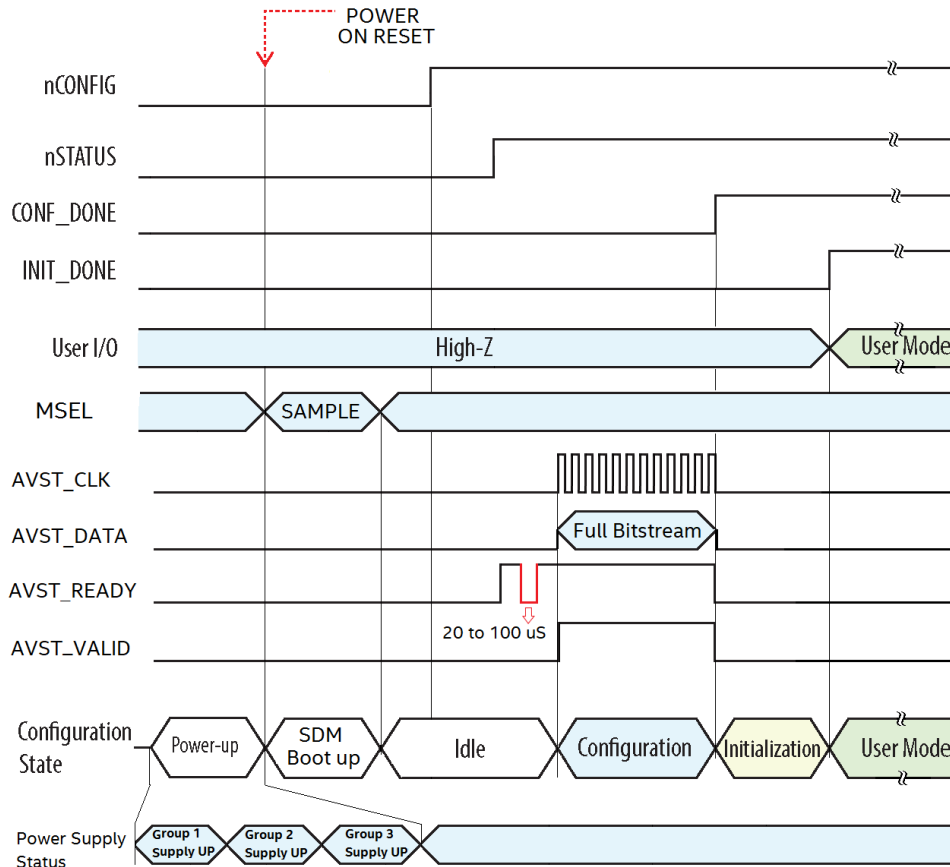
**Figure 2. Timing Diagram**

After powering up the FPGA device power supplies in the proper sequence, the device asserts a Power On Reset (POR). When you drive the `nCONFIG` pin high, subsequently the `nSTATUS` pin goes high. If you use either of the Avalon-ST configuration scheme(s) (32/16/8 bits), you may notice an unexpected low pulse (20 to 100  $\mu$ s) on AVST\_READY pin.

If you begin the configuration via Avalon-ST scheme by driving the AVST\_VALID pin high before the unexpected AVST\_READY low pulse (20 to 100 µs), then the configuration will be unsuccessful.

After the nCONFIG and nSTATUS pins are high, wait for 500 µs before you monitor the AVST\_READY pin and drive the AVST\_VALID pin to initiate the Avalon-ST configuration.
